CLINICAL CASE REPORT

ERIN DAVIS (NZROT), OCCUPATIONAL THERAPIST,
SOUTHERN REHAB, NEW ZEALAND

Enhancing positioning and maintaining skin integrity, by using Vicair cushions

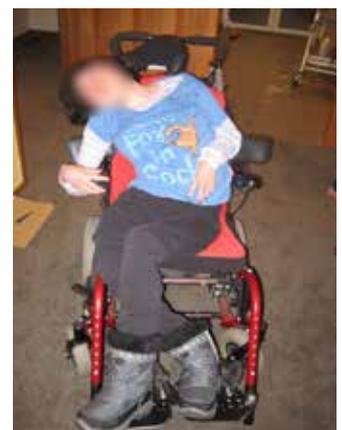
An x-ray revealed further details about Miss Y's situation and it was noted that her thoracic alignment is normal apart from mild rotational deformity in the lower thoracic. Her lumbar spine has marked rotoscoliotic deformity, convex left with a Cobb angle of approximately 46 degrees. Her pelvis is distorted with mild subluxation pubic symphysis and bilateral acetabular dysplasia. It also showed that there is complete bilateral dislocation of both hips, with superior displacement of the proximal femora. Furthermore her right leg is internally rotated.

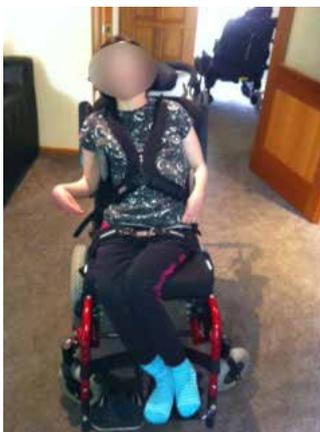
- A dual foam back support with contouring cube system on a solid shell was used. The system was custom contoured in the lumbar and thoracic spine area to support her lumbar lordosis and trunk rotation.
- D-shaped, curved lateral trunk supports (medium on right, large on left) offset were used to support her scoliosis.

- A contoured headrest.
- A centre point anterior support harness and a 2 point hip support belt were used.

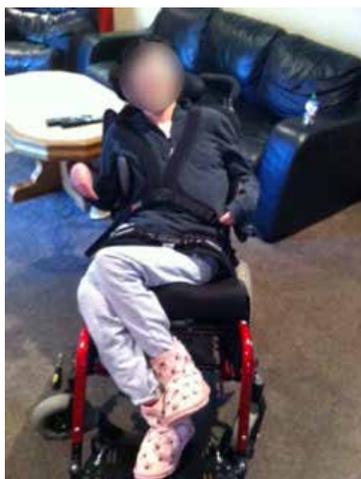
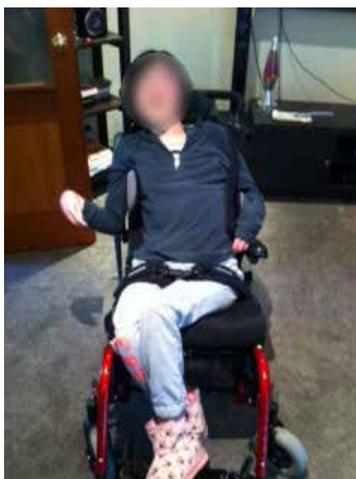
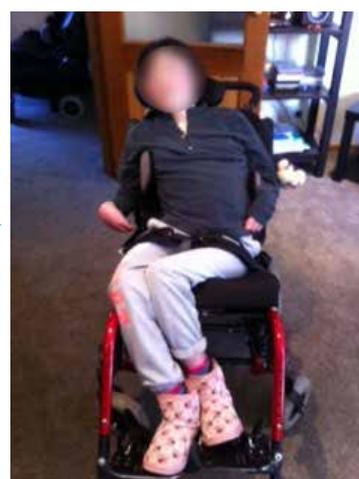
Cycle of adjustment of the seating system pre-Vicair

This seating system needed to be reviewed and adjusted every 6 to 12 months and prior to starting the clinical trial it was found that it wasn't supporting her accurately. Limited further contouring was achieved but she was starting to get reddening of her skin over her left ischial tuberosity.

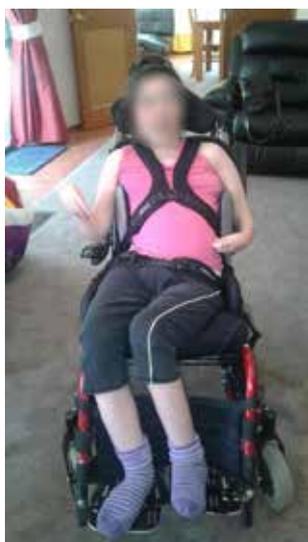
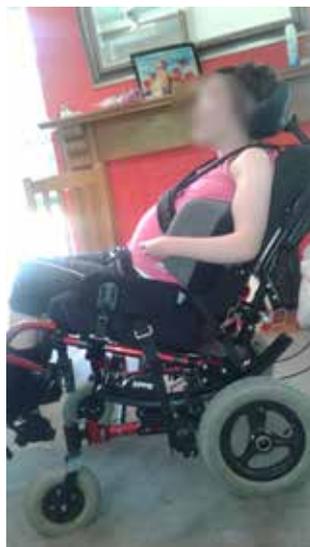
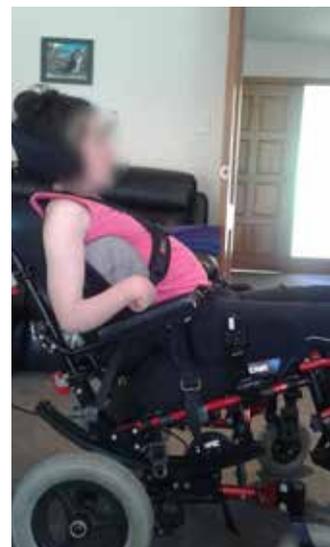
The Vicair Multifunctional back support cushion was also trialled, replacing the foam contouring on the existing back shell. It was set up with an increase in cells in the lower three compartments. It was found that Miss Y now had contact with her entire trunk and therefore gained the support in the lumbar region that she required.

Instead of sitting on top of her seating and being pushed forward, Miss Y is immersed into it. Rather than sitting on top of her cushion she is now sitting in it, therefore cradling her dislocated hips and filling all the gaps at her spine to give improved support.
