CLINICAL CASE REPORT

Addressing a positioning challenge and handling shear forces involved.

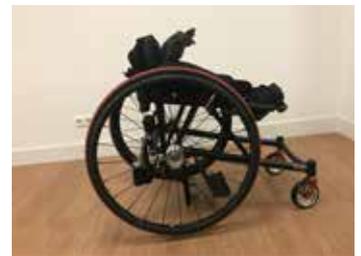
This case report mainly revolves around a positioning and stability challenge. His adjusted manual wheelchair is set up to fit the negative anterior wedge in his hips. This in practice means that the seating surface is set up in a downward angle towards the front of the wheelchair. The wheelchair has almost no back support, has a hip belt positioned around the sides, features foam knee blocks and a 3D space fibre cushion that facilitates breathability and microclimate control.

The current seating system however lacks stability for the ideal position. Mr. C. needs to reposition every 5 to 10 minutes in order to be comfortable. He feels like he is constantly sliding forward despite his belt, resulting in a lot of pressure on his lower legs just below the knees (on the kneepads). This results in redness of the skin in the knee/lower leg area. He is bothered mostly by the lack of stability when he is actively moving around in his wheelchair and often chooses to keep moving in the uncomfortable position and reposition when he reaches his 'destination'. Repositioning in itself is a tardy process in which he always needs to release the belt, reposition and fasten the belt

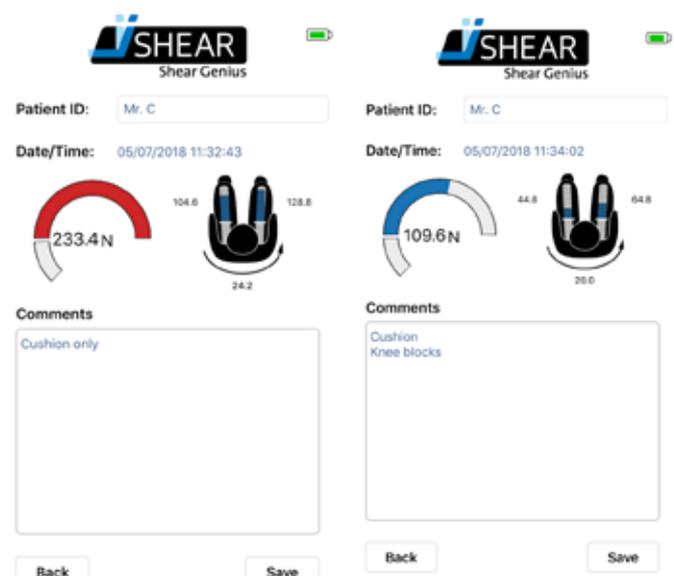
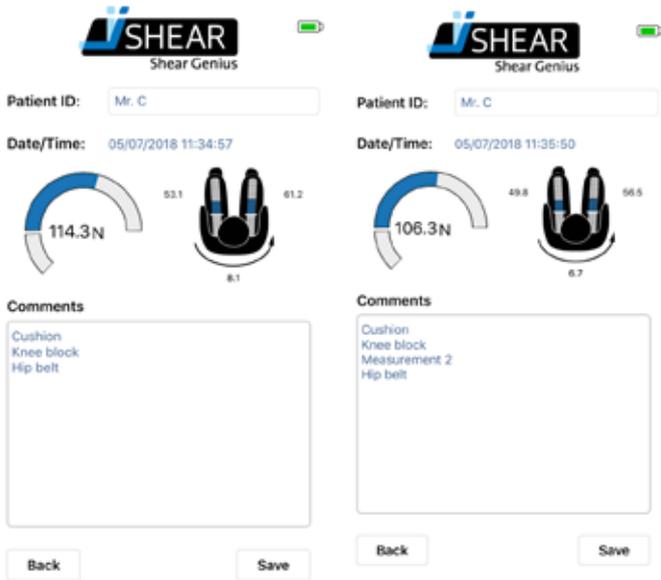
iShear shows an off-the-charts measurement of shear forces when Mr. C. is positioned in his wheelchair without any aids. When the knee blocks are applied an overall reduction of 7kg in shear forces is observed. This means that the kneepads hold a force of 3,5kg per knee. Even though the knee pads provide a reduction in shear forces, the amount of force that is left over shows that there must be a significant amount of pressure put on the knee pads. This corresponds with the indication Mr. C. gave about redness of skin in this area.

Surprisingly the shear force measurements by iShear show mixed results when the hip belt is applied. Depending on how Mr. C. (re)positions himself the belt can have a positive, negative, or no effect at all on the amount of shear force. Seeing that he repositions himself very often, there's a chance that he repositions himself into an even worse position (more shear force, more pressure on the pads) and locks this with the belt. In such a "wrong" position the belt forces Mr. C. down his seat even more, increasing the sliding effect down the fixed seating surface.

Due to his wheelchair being set in a permanent angle to better fit his fixed hip rotation, there would naturally be a tendency to slide – as in confirmed by Mr. C. in describing his problem. An iShear measurement could therefore provide a lot of insight into the shear forces created by his set up that cause the pressure on his knees. Three different situations were measured with iShear: positioned in the wheelchair without knee blocks or belt; with knee blocks and with knee blocks and belt.

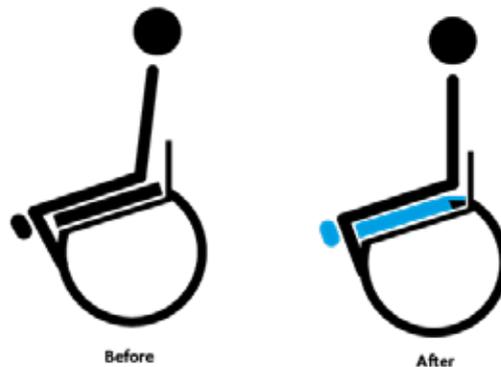
Theoretically speaking this sliding on the fixed, angled seating surface could be decreased or stopped by positioning Mr.C's IT's on a flat seating surface. A flat foam piece under his IT's however feels very hard and uncomfortable. Therefore a different solution was chosen: the combination of a wedge – that would cancel-out the sliding angle – and a Vicair cushion. The image below displays the plan in a simplified way.

The foam wedge created the flat seating surface under his IT's where the two SmartCell filled compartments above it would provide the comfort that foam alone couldn't offer.

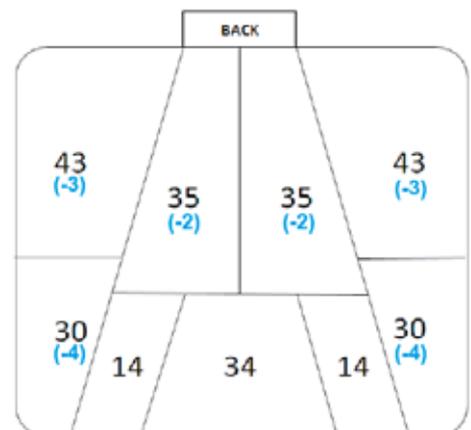
Keeping in mind Mr. C's request for stability, the Vicair Vector O2 (6cm) was chosen as the preferred cushion to fix the problem at hand. It's the most stable cushion in the Vicair range and is known for 'forcing' people into a correct position. The front compartments of the Vector would also support leg alignment. A foam wedge was placed under the two middle compartments in the back of the Vicair Vector O2. It was fixed into the right position by making use of Velcro in the Vector's cover.

In addition to changing Mr. C's wheelchair seat cushion, Vicair knee pads were made to fit his knee blocks. Implementing the SmartCell technology into the knee pads would hopefully redistribute the pressure created by the shear forces on the knee blocks, resulting in less redness and discomfort.

Because the Vicair Vector O2 (6cm) was higher than the original 3D space fibre cushion the filling grade was adjusted to facilitate a comfortable position with regards to the distance to the wheels of the chair and manual movement.

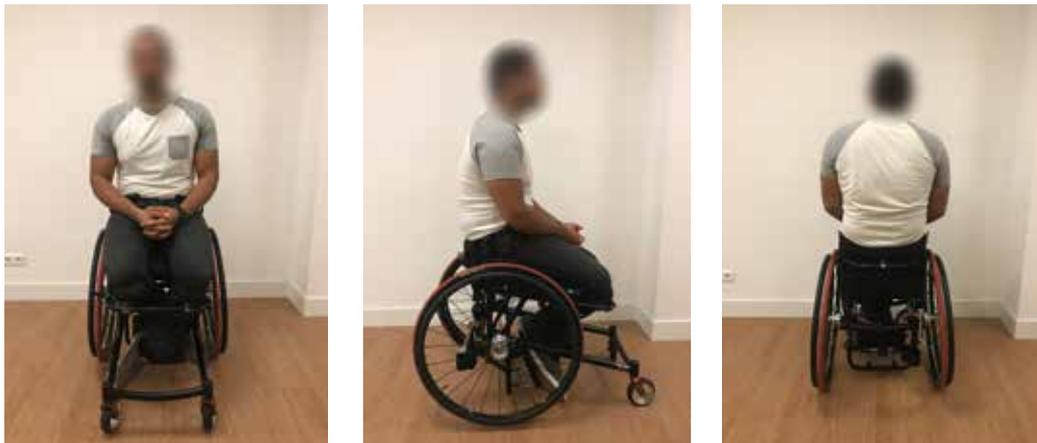
During the fitting process of the clinical assessment an immediate change was already noticeable. In testing and adjusting his new cushion, Mr. C. no longer felt the need to fasten his hip belt. On top of that he made several test rounds around the facility in his wheelchair and he did not feel the need to reposition. A definitive conclusion about the solution offered could only really be made after a longer period of testing.

After two weeks of testing his new set up, Mr. C. indicates that he barely uses his positioning belt anymore. This in itself for him is a great achievement as after previous changes he was never able to do this. Mr. C describes his new Vicair knee pads as being 'perfect', he experiences less pressure or better distributed pressure and clearly observes less redness of his knees.
